Re: LAC Minerals LLC, Cunningham Hill Mine Reclamation Project; SIC 1041; NPDES Compliance Evaluation Inspection; NPDES # NM0028711; June 19, 2018

Compliance Evaluation Inspection LAC Minerals (USA) LLC NPDES Permit No. NM0028711 June 19, 2018

NMED/SWQB Official Photograph Log

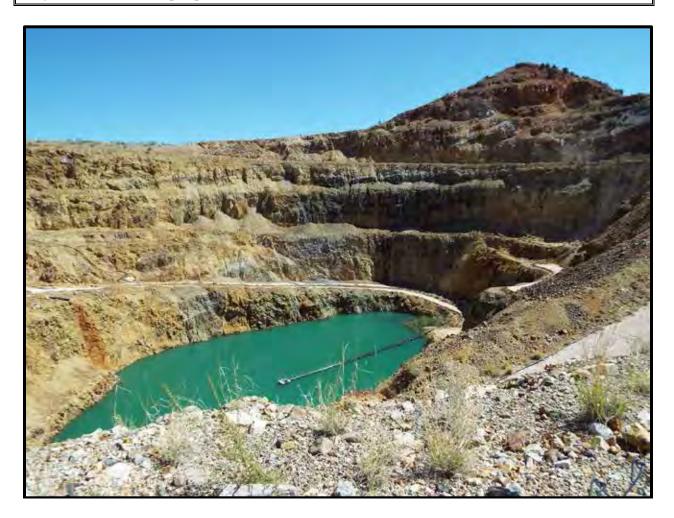
Photo # 1

Location: Picture taken from south side of LAC Minerals open pit mine facing north.

Subject: LAC Minerals open pit mine.

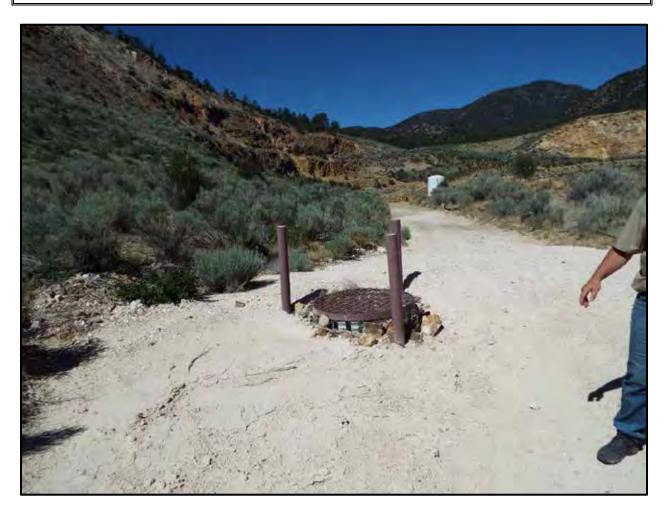
Photo # 2

Location: Picture taken from south side of LAC Minerals open pit mine facing north.

Subject: A stormwater capture system has been installed.
